GRAND-CHARITON BASIN

LAKE THUNDERHEAD DAM
PUTNAM COUNTY, MISSOURI
MO 10007

PHASE 1 INSPECTION REPORT NATIONAL DAM SAFETY PROGRAM

MAY, 1980

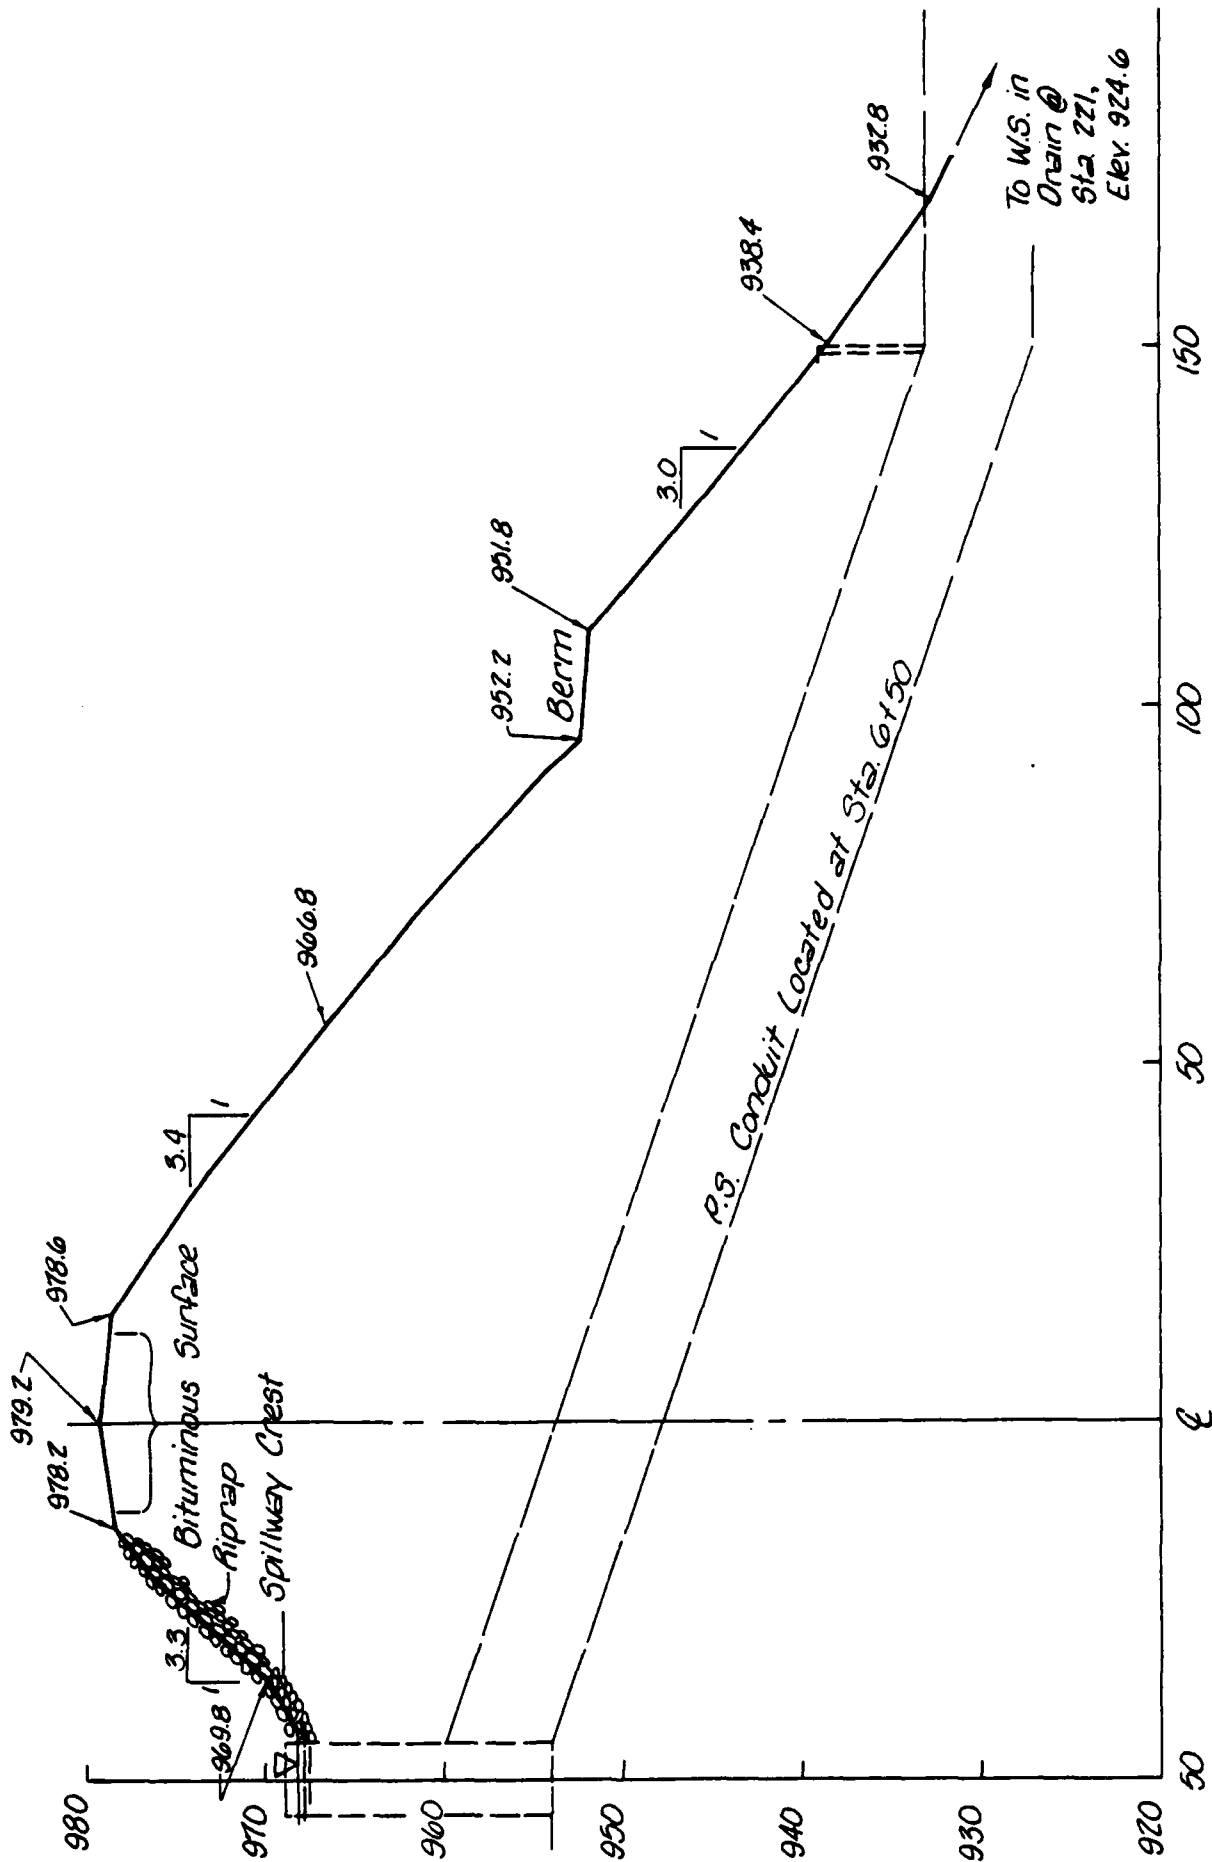
MAXIMUM CROSS-SECTION AT STATION 10+00
(As Measured by Inspection Team)

One small rodent hole was observed (Photo No. 21), but others could be present. Measurements of the slope presented on Plate C-31 indicate that it is slightly flatter than the 1V on 3H shown on the plans. There is some indication of wetness in the surface drainage ditch along the upstream edge of the berm as shown in Photo's 20 and 38. However, this wetness on the berm appears to be due to imperfect discharge of surface drainage. There were no indications of erosion, bulges, slips or other deformations on the slope. There were no indications of seepage on the slope or along the toe of the principal embankment. However, there is considerable seepage outcropping around the walls of the sewer lift station located downstream from about station 8+00 and about 100 feet right of the principal spillway outlet structure (S.A.F. basin). Plates C-28, C-29 and C-30 show the location and plans for the lift station which will serve the sewer line passing under the reservoir and dam from the west side of the lake. Photo's Nos. 23, 25, 26, 27, and 28 show the seepage around the lift station. The seepy area is very spongy and semi-bouyant. Seepage discharge from the area, part of which is shown in Photo 26, is estimated at about 1 g.p.m. The sewer line into the lift station is not in use and is capped at its termination in the bottom of the station as shown in Photo No. 39. The floor of the lift station is essentially dry as shown in Photo No. 40.

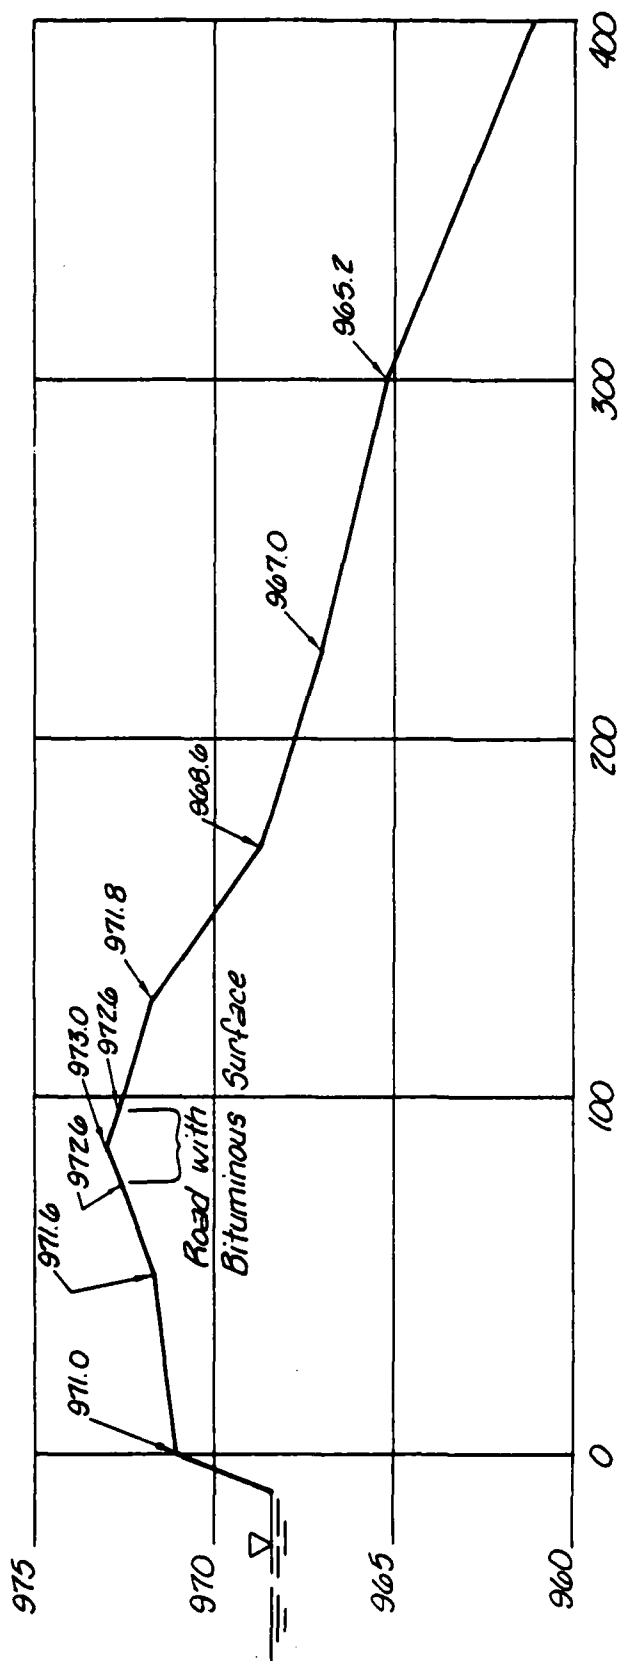
PROFILE ALONG EMERGENCY SPILLWAY CENTERLINE
(As Measured by Inspection Team)

- (2) The emergency spillway is well vegetated with adapted grasses as shown in Photos 3, 4, 5 and 6. (No slumps, erosion or deformations were noted in the spillway). The asphaltic roadway across the dam crosses the spillway and serves as the crest or control section of the spillway. The spillway has never operated. Some seep areas were observed toward the lower end of the outlet channel as shown in Photo No. 36. Discharge was clear and too small to estimate. A considerable amount of seepage was observed along the left side of the outlet channel, adjacent to the north sewage lagoon. Most of this seepage appears to originate from the lagoon(s). Seepage discharge from this area was clear and estimated at 2 to 3 g.p.m. The emergency spillway channel discharges into the exit channel for the principal spillway. Emergency spillway discharges should not encroach upon the dam.
